**CRICKET - PROPOSED PLAY AREA SAFETY INSPECTION
REPORT**

THURROCK COUNCIL

ORSETT RECREATION GROUND

5 March 2009

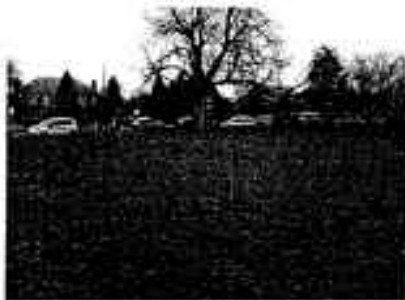
Plate 2 Proposed location of play area (A)

The play equipment which is proposed for installation would be used by toddlers through to the age of 13 years. The location we understand was agreed after local consultation. The areas concerned were originally identified as (A) and (B) with a consultation process being undertaken to gain local opinion on the favoured location of the play area. (A) Being the cricket outfield and (B) being the corner of the football area. Option 2 (plate 3) is we understand the favoured option spreading the play equipment between both fields (A) and (B) covering a triangular area of the cricket outfield and the corner of the football field. Another option was originally put forward spreading all the play equipment along area (A).

- Central for the village users.
- Close to the entrance, car park and accessible from the pathway.
- Overlooked by local houses across the road
- No other appropriate local location available
- This also retains the football pitch practise area & informal area behind the goal post which would stop possible use of cricket outfield for this purpose by the football club and other informal users.

- Possibility of cricket balls accessing proposed play area
- School Lane (Road)

A form of barrier (fencing) should be installed especially between School Lane (Road) and the play area. The exact location and the extent of the barrier (fencing) will also need to be agreed. Signage at appropriate locations should also be installed both on the road and within the proposed play area as already indicated for both aspects within the report.

The most appropriate action to reduce the risk of cricket balls accessing the proposed play location would be to install ball stop netting at the edge of the proposed play area, although the cricket club have already indicated to the Council that this is not required due to the possibility that balls will go over the top of any netting this is of course understood, however netting is designed to stop most balls. Installation of ball stop netting has been found appropriate elsewhere in the country such as adjacent to children's play areas or at the boundaries of housing where cricket is played to reduce the overall risk factor.

Dependent upon the height and location of the netting deemed appropriate and agreement that the netting should be installed, the risk factor for the proposed play area could be reduced. Permanent netting may not be suitable for the location and perhaps mobile netting would be more suitable which is installed prior to cricket matches taking place discussions will need to be had to decide the most appropriate course of action and whether planning permission for more permanent netting is required if this is agreed as appropriate.
